## STRUCTURE EXPLORATIONS

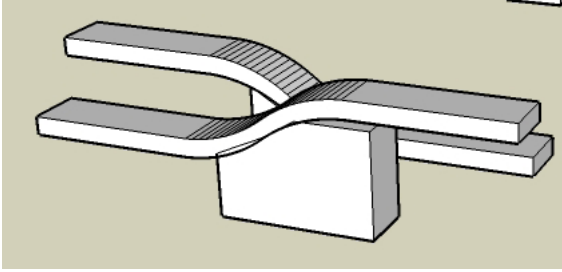
Central support

- Adequate legroom
- Problematic cantilever
- Somewhat elegant

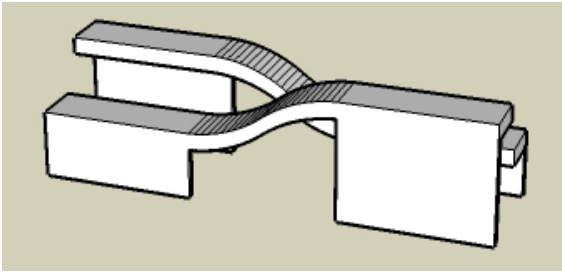
Side supports

- Central support lacking
- Design issue/opacity
- Awkward seating

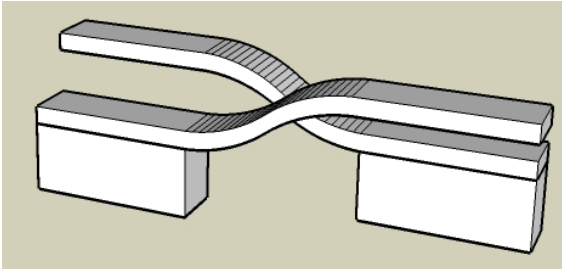
Edge supports

- Central support lacking
- Design issue/opacity
- Cantilever/central support issues

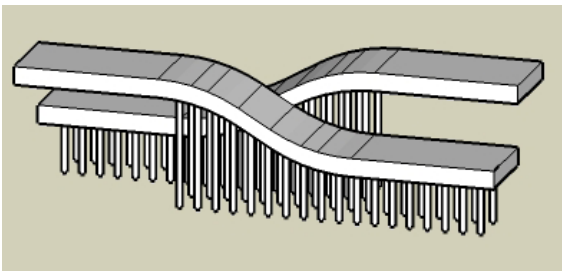
Numerous metal rod supports

- Child safety issue between bars
- Design/elegance
- Foundations, maintaining the components straight on the site

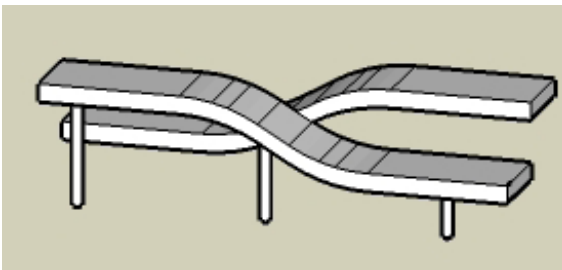
Specific metal rod supports

- Design/elegance
- Foundations, maintaining the components straight on the site

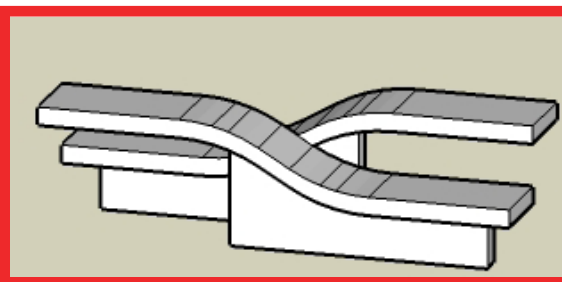
Spine support

- Elegant
- Adequate legroom
- Possible cantilever problematics
